Newsletter no. 5

June 2009/JV/CA/FMH

The monitoring of all 3 facilities is approaching its last phase and the first conclusive results are beginning to show. Each facility makes use of a different innovative technology to treat the runoff water. The objective of the project is, amongst other, to test these technologies and compare their effectiveness. The effectiveness is then compared with practical and financial issues related to construction and operation of the facilities.

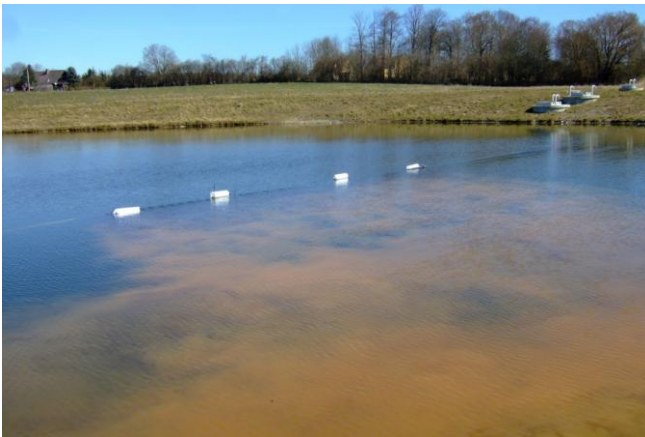
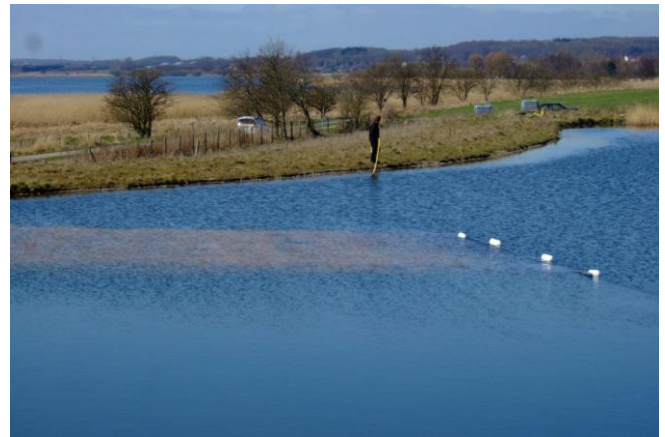
Figure 2. Addition of iron salts to the pond in Århus. A total of 3 tons of solution was added to the pond.

At the facility in Århus, iron addition to the bottom sediments has been tested. The intention is that the increases iron concentration will increase the sorption capacity of the pond bottom. This technology is well-known from lake restoration but has hitherto not been tested on wet detention ponds. Iron was dosed to the basin in the beginning of April (Figure 2).

It is still too early to say how effective the technology is as such analysis demands a large number of water quality samples. It is, however, clear that the algae growth – and thereby the biological availability of phosphorous – has been significantly reduced compared to a pond without iron addition.

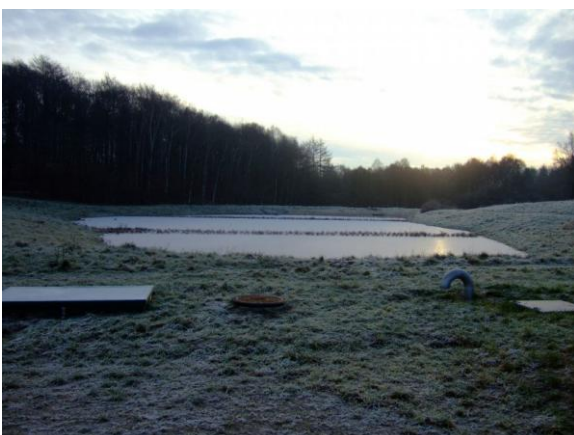
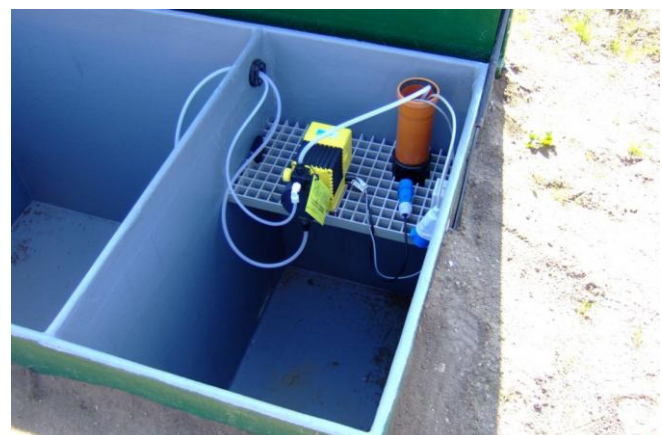
Figure 3. The facility in Silkeborg. On the left hand picture the lid of the container for aluminum dosing is seen. On the right hand picture, the dosing pump and space for a pallet containing the aluminum is shown.

The technology which is tested in Silkeborg is also inspired by lake restoration technologies. At this facility, aluminum salts are added to improve the treatment efficiency of the wet detention pond (Figure 3). Opposed to Århus, the aluminum is added flow proportionally to the inlet during rain. The addition was started up in the middle of April and there are still insufficient data to tell how effective the technology is. However, and similar to the first results from Århus, the algae growth has been strongly limited by the addition, indicating that the technology is effective – at least towards phosphorous. At the same time there are no indications to increased aluminum concentrations in the outlet.

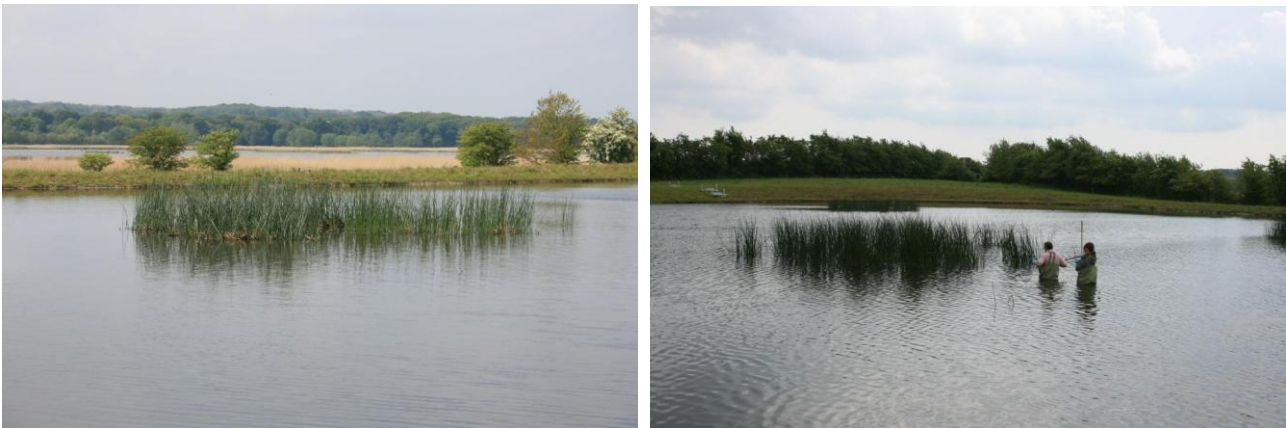
Figure 4. The photographs show sampling during a visit. The first row shows the system at Århus. The second row shows a sediment core and accreted sediment selected for analysis.

The sampling campaigns included the gathering of sediment and plant material for the evaluation of heavy metals and selected organic micro-contaminants in sediment and plants. Visits to the sites have been done to assess plant health, and system performance.
